Manhole Inspection Summary

Manhole # S17G__011MH

Insp Date: **10/5/07 11:39 AM**

Location Address: **2521 FAIRMOUNT-BALTIMORE** Cross Street: **CATHERINE ST**

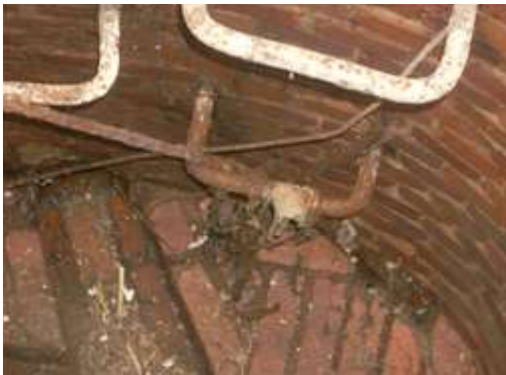
Defect 3

Steps Count: **5** Missing: **0** ☒ **Corroded**

Surcharge ☒ **Evidence Of Surcharge** Depth: **3** (ft.) ☐ Active Surcharge Present

CORRODED STEPS WITH SRCHARGE EVIDENCE

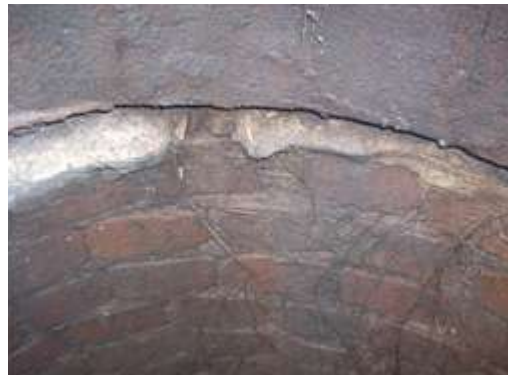
Defect 2

Corbel Material: **Brick** ☐ Parged Type: **Concentric/Eccentric**
Condition: ☐ Sound ☐ Cracked ☒ **Root Intrusion** ☐ Loose Brick ☒ **Deteriorated**
Infiltration: ☒ None ☐ Joint ☐ Cracks ☐ Mortar ☐ Roots ☐ Wall

DETERIORATED CORBEL WITH ROOT INTRUSION

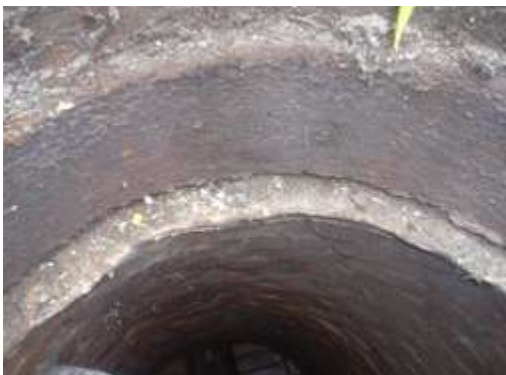
Defect 1

Frame Offset: **1** (in.) Condition: ☒ Sound ☐ Cracked ☐ Leaks

FRAME OFFSET

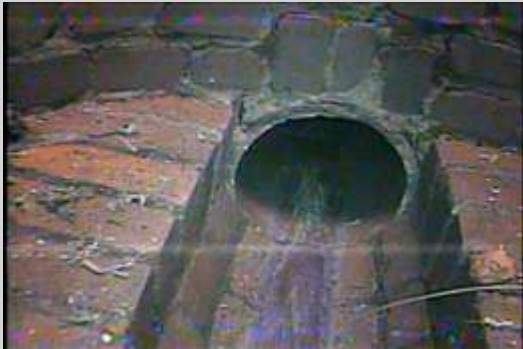
12 O'Clock Outflow

Pipe Height: **7.2** (in.) Rod and Bar (Angled)
Pipe Material: **Clay** ☐ Pipe Lined
Invert Depth: **8.82** (ft.) Flow Characteristics: **Fast**
Deposits: ☒ None ☐ Mud ☐ Sludge ☐ Debris ☐ Grease
Silt Depth: (in.) Deposits Extent:
Infiltration: **None** Pipe Seal Cond: **Broken**

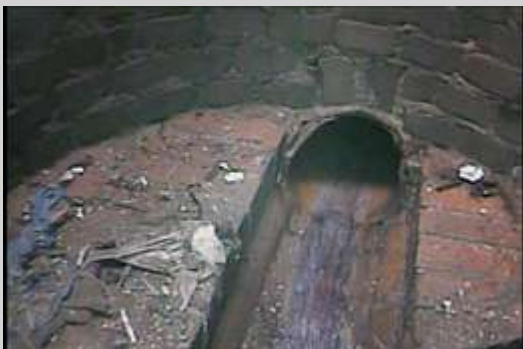
6 O'Clock Inflow

Pipe Height: **8.4** (in.) Rod and Bar (Angled)
Pipe Material: **Clay** ☐ Pipe Lined
Invert Depth: **8.60** (ft.) Flow Characteristics: **Fast**
Deposits: ☒ None ☐ Mud ☐ Sludge ☐ Debris ☐ Grease
Silt Depth: (in.) Deposits Extent:
Infiltration: **None** Pipe Seal Cond: **Broken**

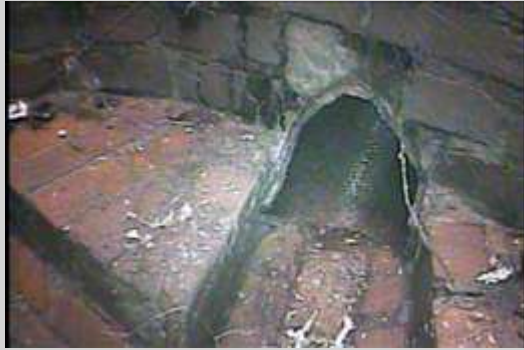
9 O'Clock Inflow

Pipe Seal Cond: **Broken**
